Opal Botany Mill

DA 05_0120

Annual Environmental Monitoring Report (AEMR)

Operation Compliance Report July 2020 – June 2021

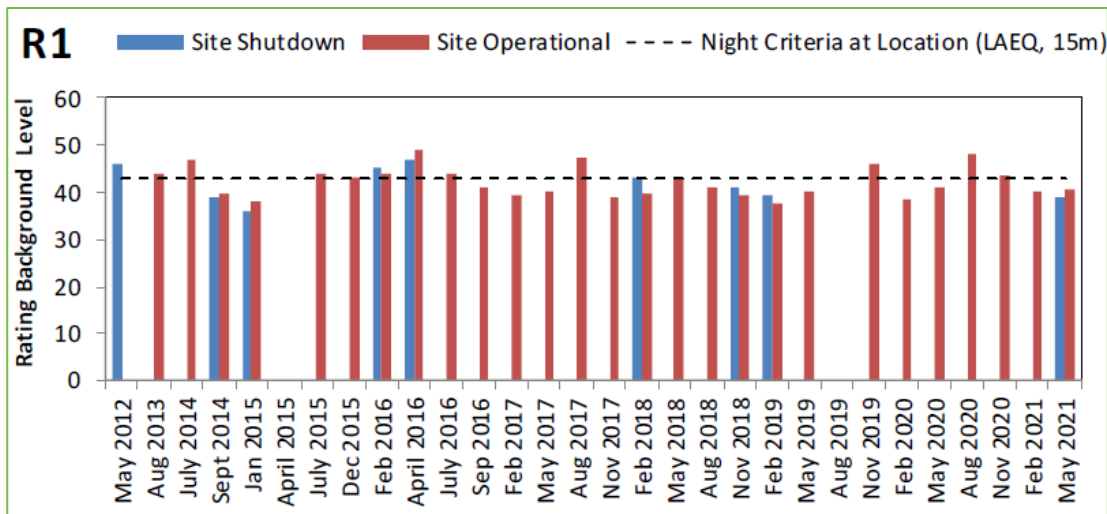
Figure 4: Historical background noise levels at R1

Tables 2 to 6 give the noise levels measured during the reporting period at each monitoring point. Comparisons of results from these monitoring periods with criteria and historical monitoring are shown in Figures 4 – 9. While these historical background noise levels are not directly related to the L_{Aeq} criteria from the EPL, they provide an indication of the change in background environmental noise levels corresponding to the regular noise surveys undertaken for the Botany Mill site. There are no overall trends shown in Figures 4 – 9.

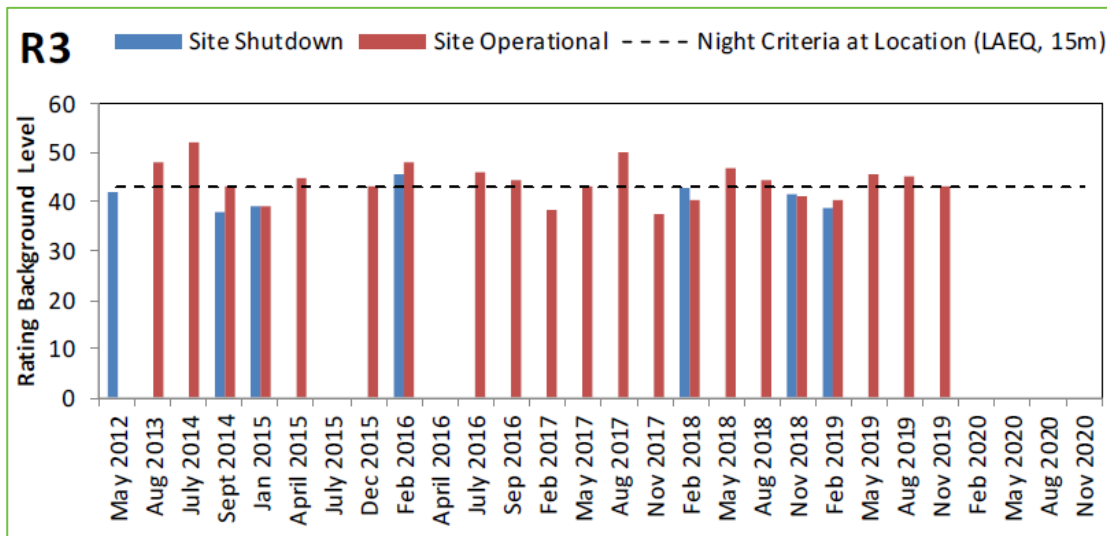
Figure 6: Historical background noise levels at R3

Access to location R3 was withdrawn in February 2020 and is unlikely to be available for future noise surveys. This has been discussed with the EPA.

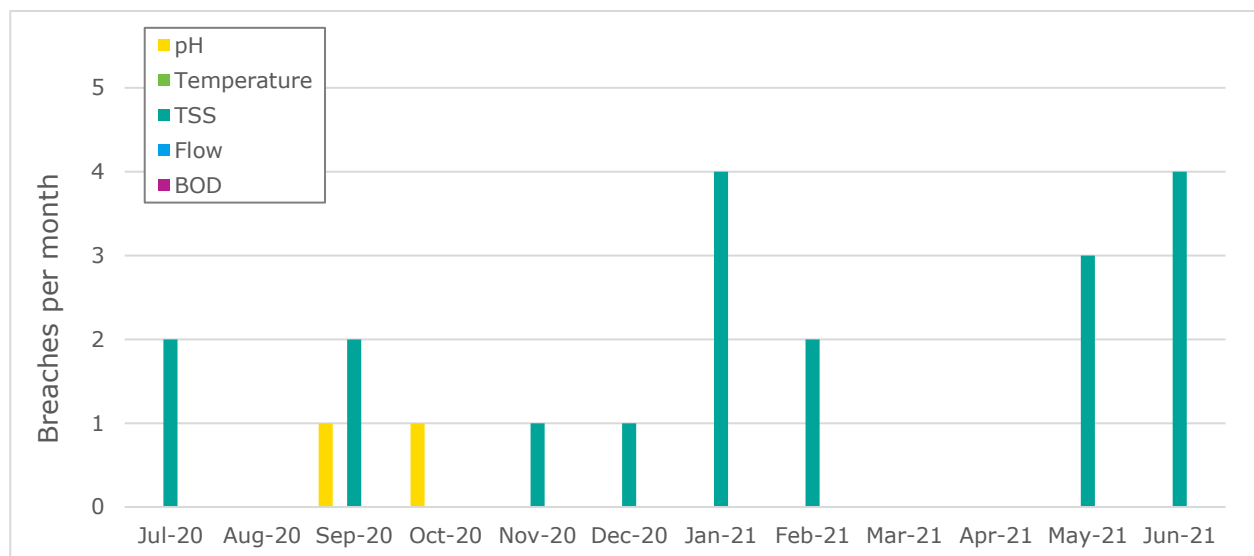
Figure 10: Breaches of Consent to Discharge Industrial Trade Wastewater in 2020-21

Nineteen breaches of the Consent for Suspended Solids were recorded during the reporting period, as shown in Figure 10. These were a combination of both concentration and total daily mass breaches. All breaches were reported to Sydney Water.

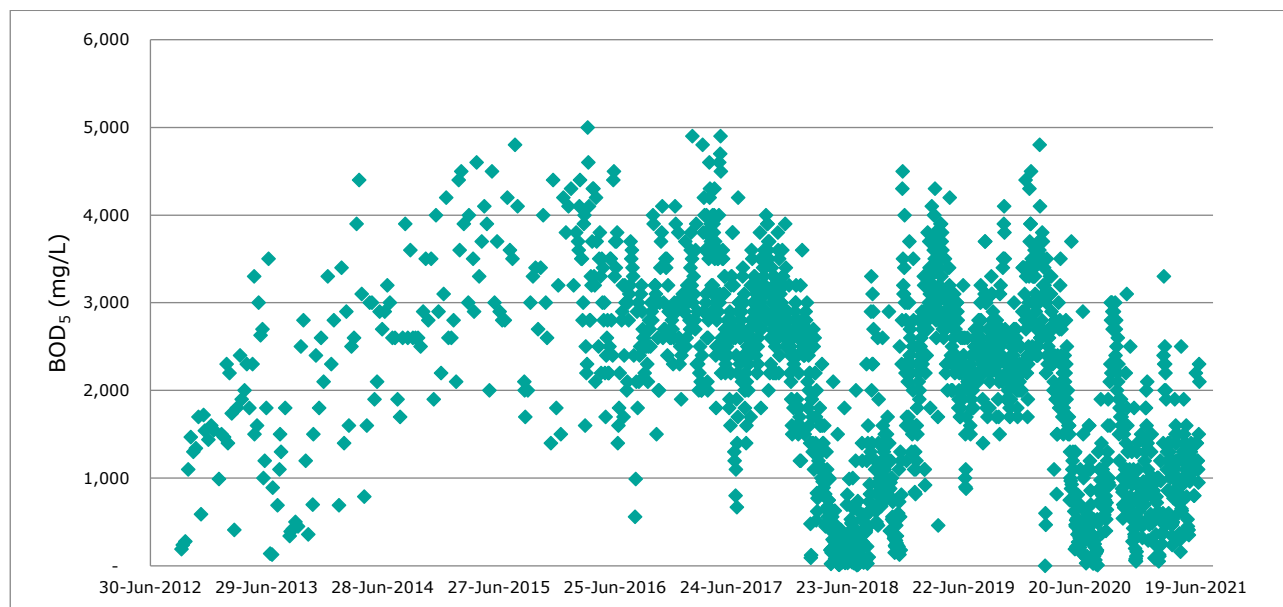
Figure 11: Biological Oxygen Demand in effluent – historical data

Figures 11 to 14 show historical trends for the relevant pollutant test results. The variation in BOD₅ results is due to the secondary water treatment plant (SWTP) commissioning in 2018, followed by unreliable running of the SWTP in 2019, and recommissioning in 2020 after significant maintenance works.

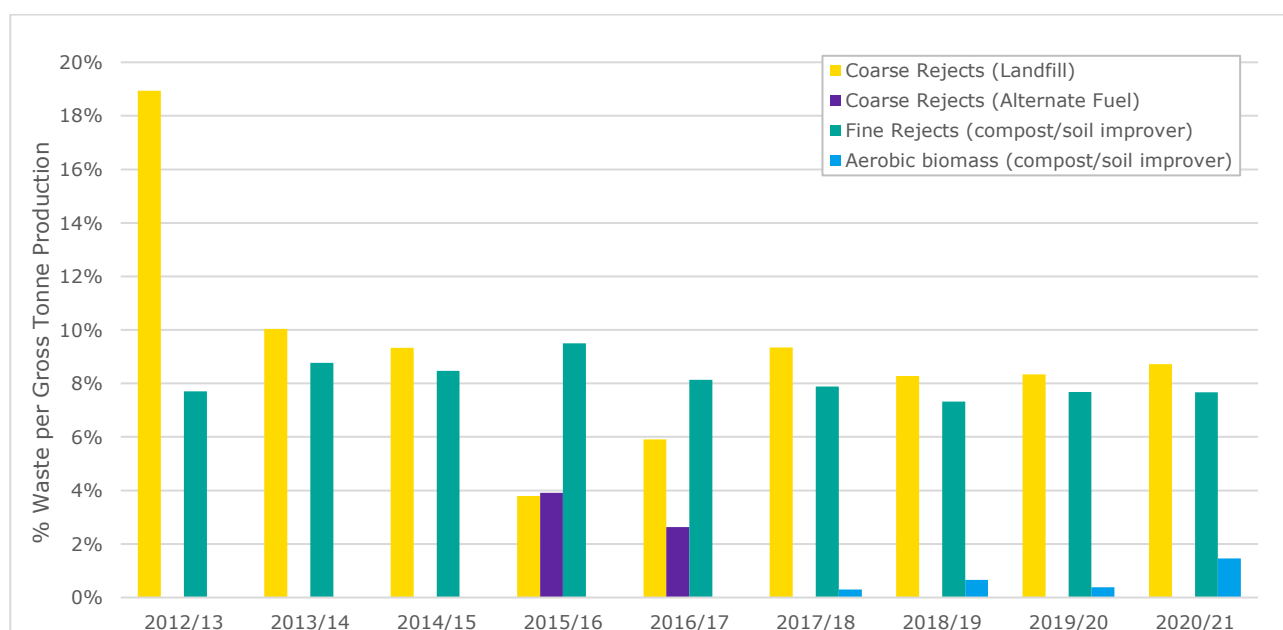
Figure 15: Process Waste Trends

Waste stream	Waste Management Plan	Current Performance	Management
Coarse Rejects	47,000 T	37,906 T	Landfill
Fine Rejects	36,000 T	33,346 T	Composting and re-use as soil improver under EPA exemption
Aerobic Biomass	9,000 T	6,369 T	Composting and re-use as soil improver under EPA exemption
Waste Oil	20,000 L	15,300 T	Recycled

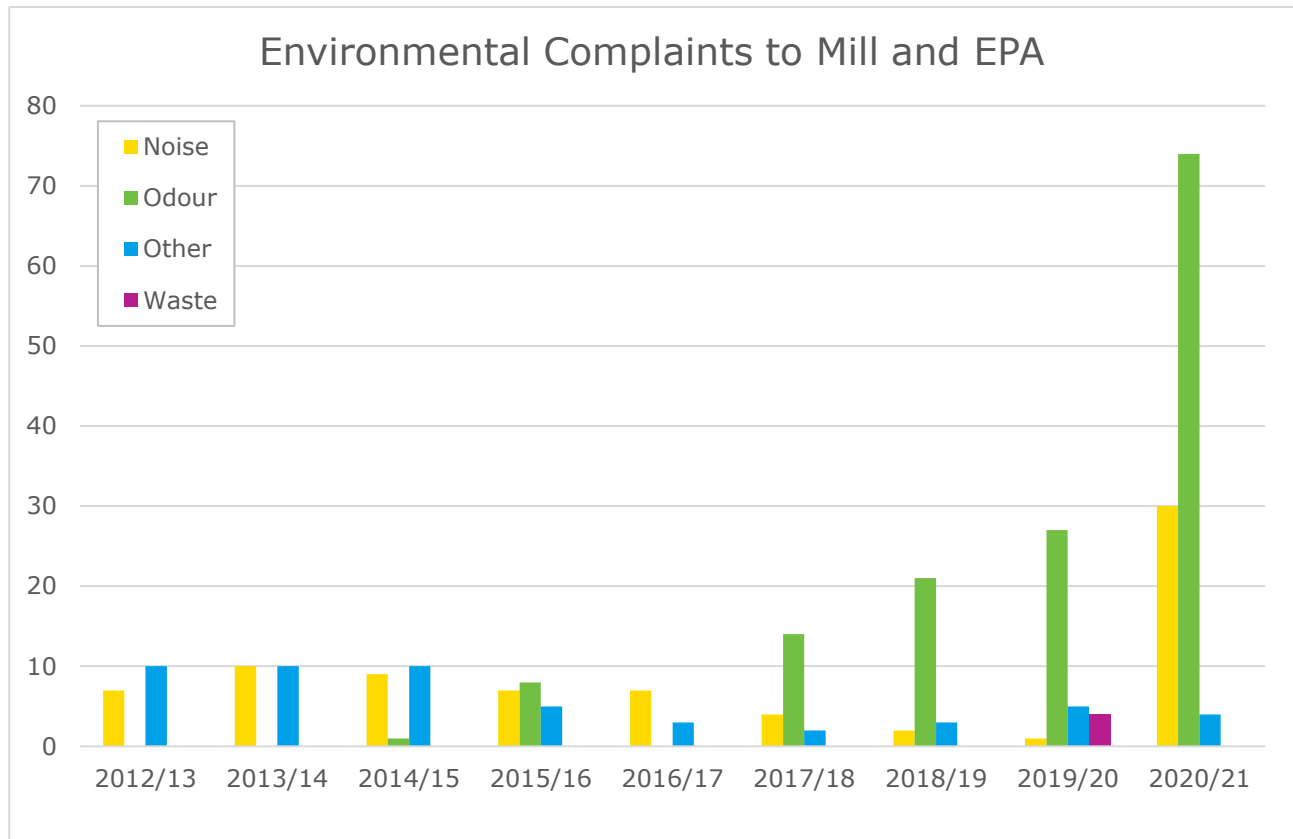
Figure 16: Environmental Complaints to Mill and EPA

The cause of the odour complaints cannot be linked to any process conditions or upsets. Odour surveys conducted during the reporting period did not identify any offensive odours in the residential area related to mill operations. An odour strategy has been developed and discussed with the NSW EPA. An odour consultant has been engaged, and sampling and odour assessment of individual emissions points will be conducted during the next reporting period. This assessment will quantify and characterise the odour at each emission point.

The majority of noise complaints received during the reporting period were related to low frequency, engine idling and rumbling noise. This is most likely related to other operations in the Port Botany area. Some complaints towards the end of the reporting period for a humming or whining noise appear to be related to occasional high output from aeration blowers on site. This matter is still under investigation and operating conditions around these blowers are being closely monitored.

Other complaints were recorded for tree trimming, litter, a traffic incident, and site security.
