# HV Line Bushfire Mitigation Management Plan

## 1. INTRODUCTION

Opal ANZ Pty Ltd Maryvale Mill operates 15 spans of 22kV overhead lines stretching approximately 1400m in a defined hazardous bushfire risk area. The Mill is required by State Acts and Regulations to have a Bushfire Mitigation Management Plan. This document is provided to meet the legislative requirements.

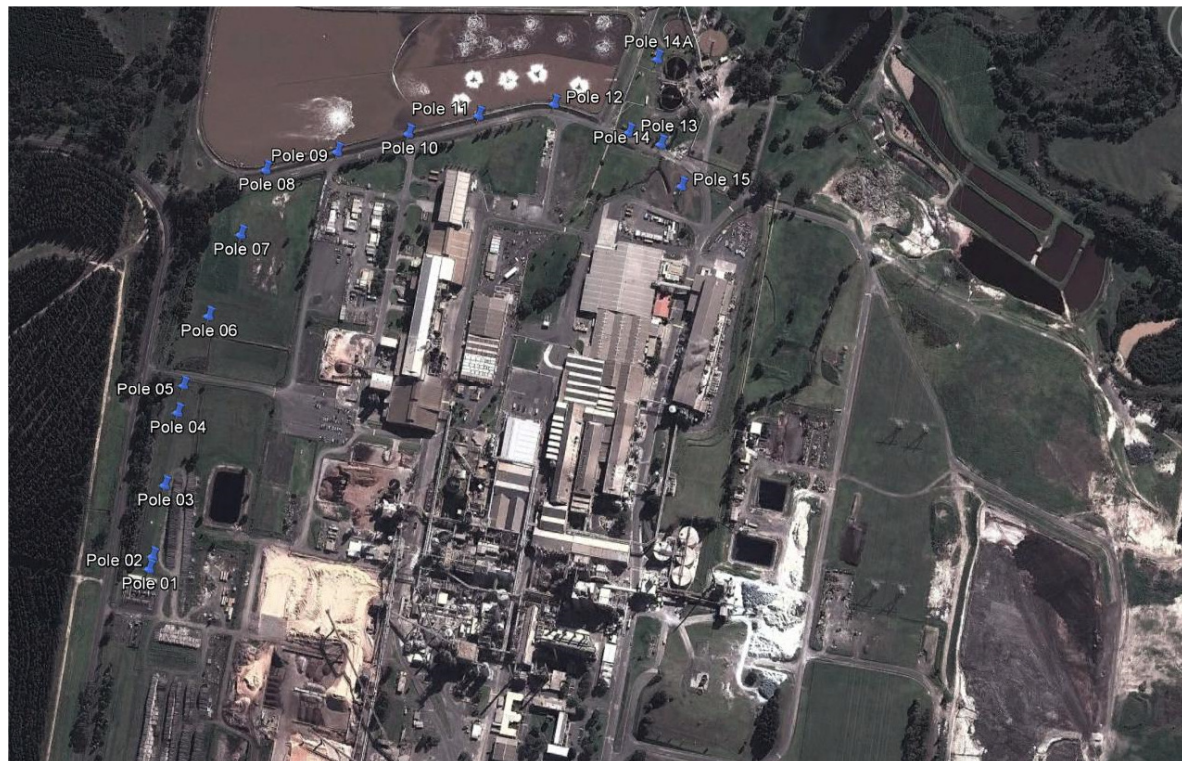
The 22kV overhead lines covered under this Management Plan are supplied from 22KV switchboard V601-22 and supported by 16 concrete poles stretching approximately 1400m in the locations as shown below.

The conductor is three phases of 120mm<sup>2</sup> Aluminium and 1400m length. These poles and overhead line have been installed in 1998.

Pole Number	1	2	3	4	5	6	7	8	9	10	11	12	13	14	14A	15
Pole ID	2719 906	2719 907	2719 908	2719 909	2719 910	2719 911	2719 912	2719 913	2719 914	2719 915	2719 916	2719 917	2719 918	2719 920	2719 919	2719 921
Pole Latitude	38° 10' 56"	38° 10' 55"	38° 10' 52"	38° 10' 50"	38° 10' 49"	38° 10' 45"	38° 10' 41"	38° 10' 38"	38° 10' 37"	38° 10' 37"	38° 10' 36"	38° 10' 35"	38° 10' 36"	38° 10' 37"	38° 10' 33"	38° 10' 38"
Pole Longitude	146° 26' 29"	146° 26' 30"	146° 26' 30"	146° 26' 31"	146° 26' 32"	146° 26' 33"	146° 26' 34"	146° 26' 36"	146° 26' 40"	146° 26' 44"	146° 26' 48"	146° 26' 52"	146° 26' 57"	146° 26' 58"	146° 26' 59"	146° 26' 60"

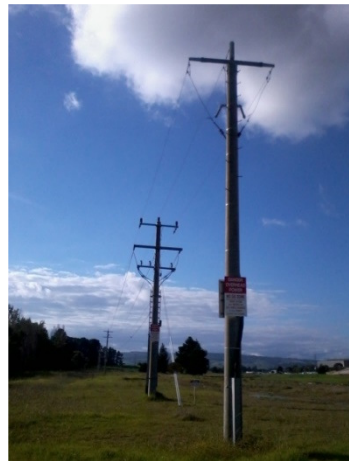
Pole 1&2: looking North

The 22kV lines run through cleared private property owned and managed by Opal Australian Paper on a large industrial site. Images of some typical poles are show below.
